INTERIM REPORT

SINKING OF THE VESSEL BOURBON RHODE ON 26 SEPTEMBER 2019

DATE OF ISSUE: 15 April 2021

Report N° AET/TM-2021/01

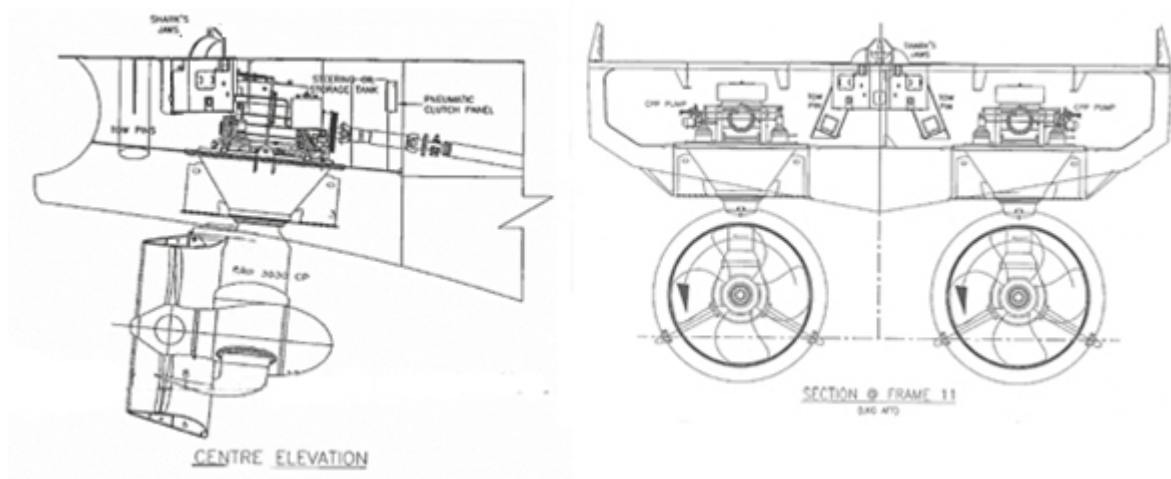
Figure 3.5 – Bourbon Rhode, Z-Drive compartment plan
(Source: Bourbon Marine & Logistics, modified by the AET)

The Z-Drive compartment space accommodated the Z-Drive azimuth pods, including the related hydraulic pumps and electrical cabinets. The installed electrical equipment included the port and starboard Schottel rudder propeller terminal boxes, the port and starboard pitch aggregate terminal boxes, feedback units and the pitch warning transmitters.

The steering system and electrical cabinets were positioned on floor plate level. The cabinets were open at the base and thus left the electrical components unprotected against water in case of flooding.

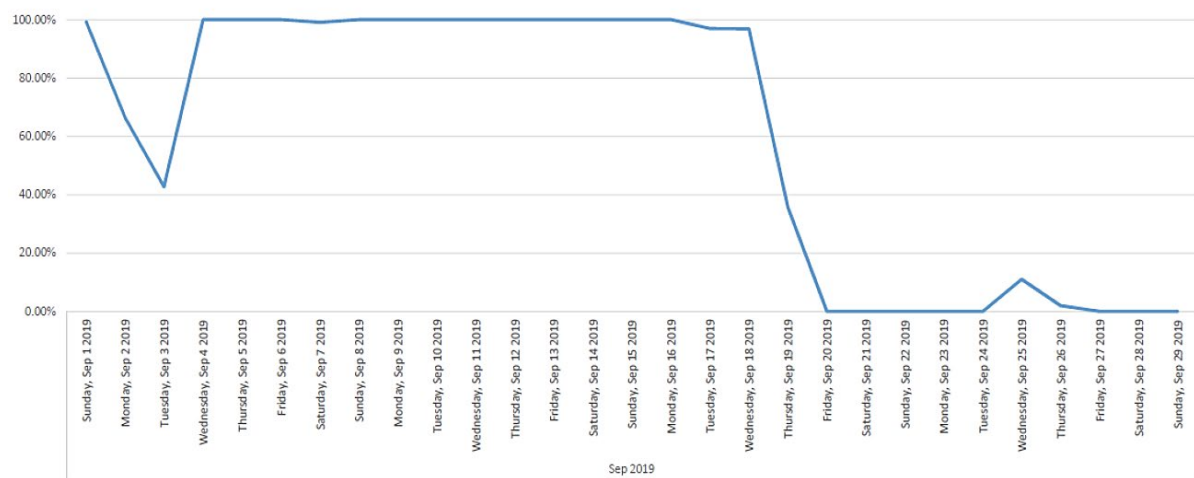
Figure 3.14 – *Bourbon Rhode*'s VSAT availability graph for September 2019
(Source: Bourbon Marine & Logistics)

From 19 September 2019, the VSAT performance became unreliable.

The reboot request was forwarded to the *Bourbon Rhode* on 20 September 2019. At that time the VSAT reception had already been erratic.

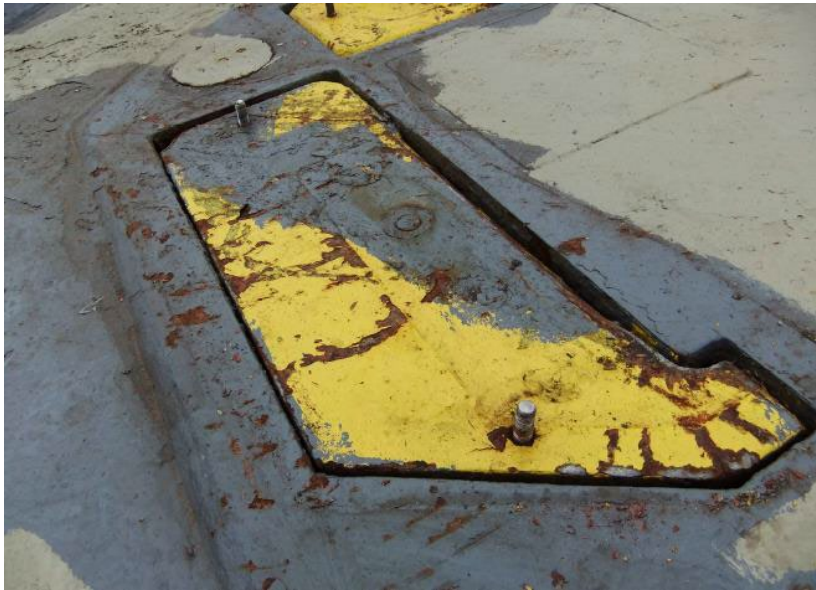
Figure 3.20 – *Bourbon Rhesos*, Shark Jaw retracted position
(Source: Bourbon Marine & Logistics)

During operation, water from the deck can enter the watertight housing frames. When not in use, the Shark Jaws and the towing pins are lowered into their housing frames and are flush with the deck. In lowered position, gaps around the shark jaws also allow water to enter the housing frame. This issue is of lesser importance regarding the towing pins, due to smaller gaps.

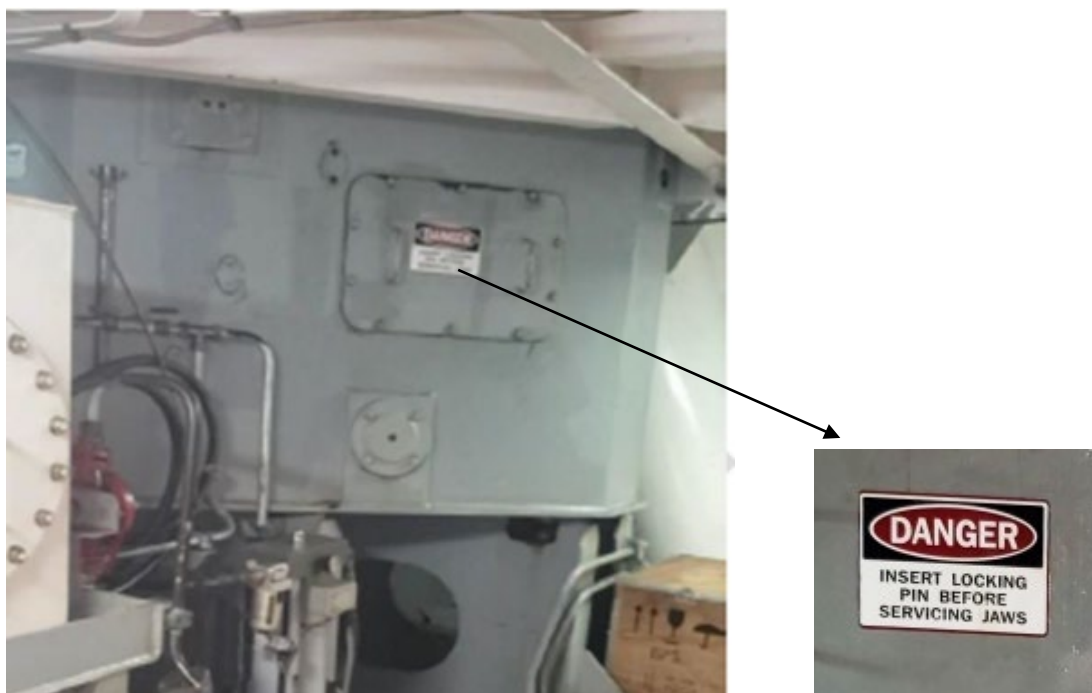
Figure 3.21 – Self-contained system as seen from inside the Z-Drive compartment's port side, *Bourbon Rhesos*, November 2019
(Source: Bourbon Marine & Logistics)

The Shark Jaws housing frame situated below deck inside the Z-Drive compartment is equipped with four inspection covers (one forward, one aft and two side covers) for maintenance of the system. The inspection covers are to be fitted with a silicone sealant or a gasket and are secured by bolts.

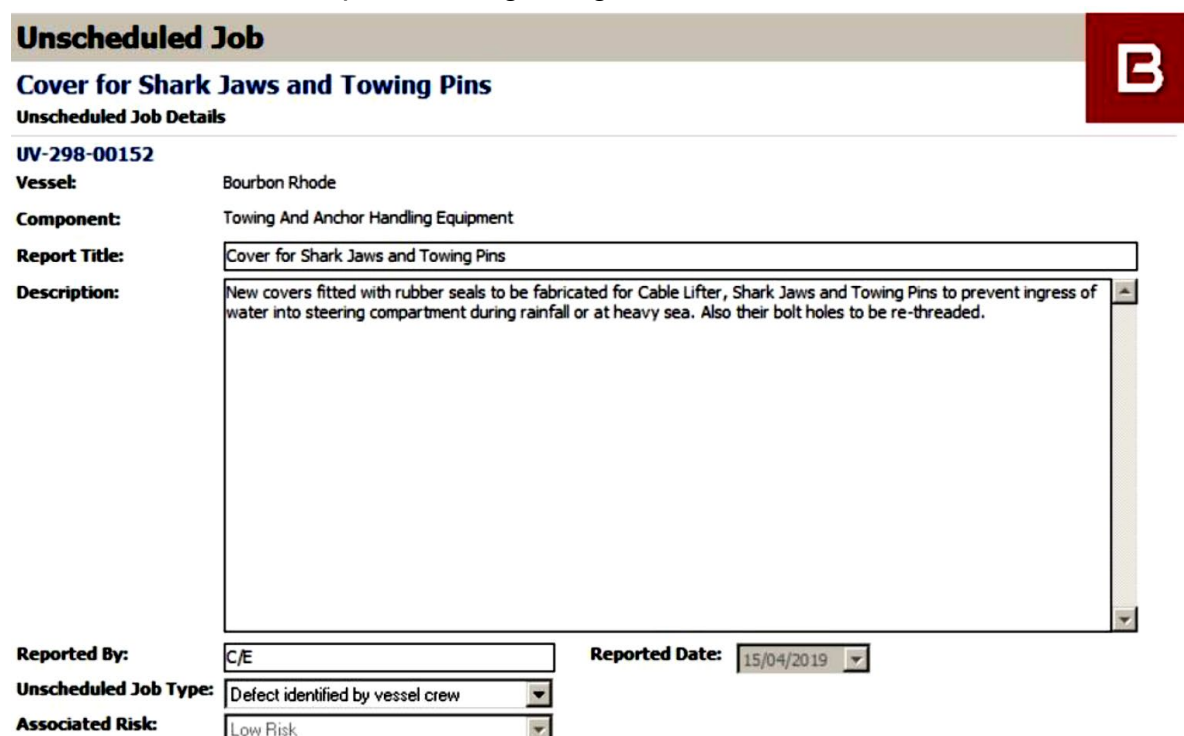
Unscheduled Job

Cover for Shark Jaws and Towing Pins

The *Bourbon Rhode* technical inspections report from 19 May 2019 identified the inspection covers to be leaking, with evidence of staining on the housing frame.

- The first on 19 April 2019 regarding the fabrication of new covers;

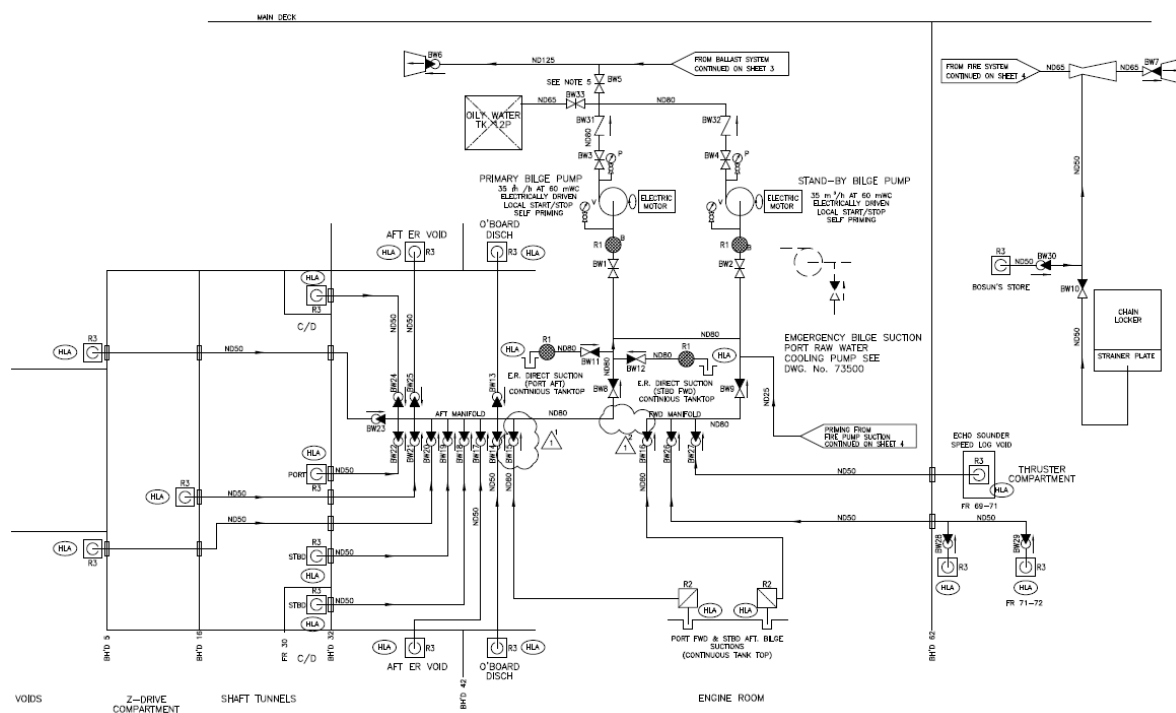
Figure 3.32 – Bilge pump system
(Source: Keppel Singmarine, received by the CAM)

The bilge wells of the compartments were connected to the bilge pump located in the vessel's engine room on the starboard side by one 2" pipe. The vessel was equipped with a primary and a stand-by bilge pump. The 2 bilge pumps had a capacity of 35 m³ per hour each. In case of water entering the bilge well, a high level bilge alarm was triggered on the Noris Alarm System and the bilge pump had to be activated manually to evacuate the water. An automatic bilge pump activation linked to a high level bilge alarm was not implemented.

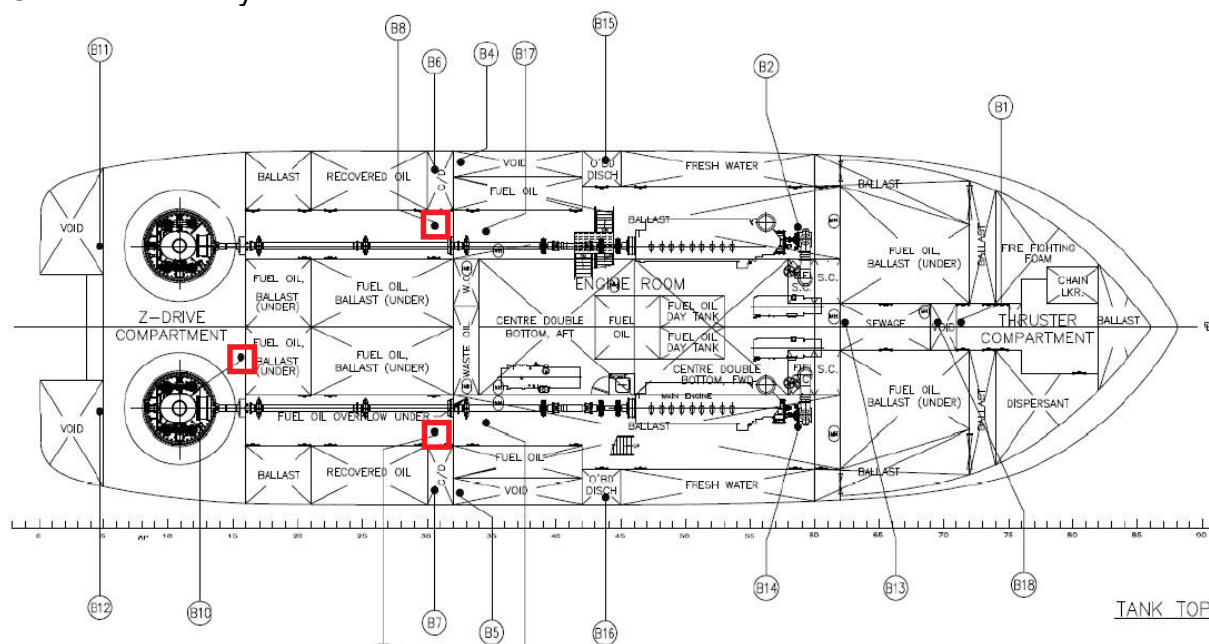
Figure 3.33 – Bilge High Level Alarm Sensors Location
(Source: Bourbon Marine & Logistics)

The above drawing shows that one bilge high level alarm sensor was located in the bilge well of the Z-Drive compartment and one in the bilge well of each shaft tunnel further forward (highlighted in red).

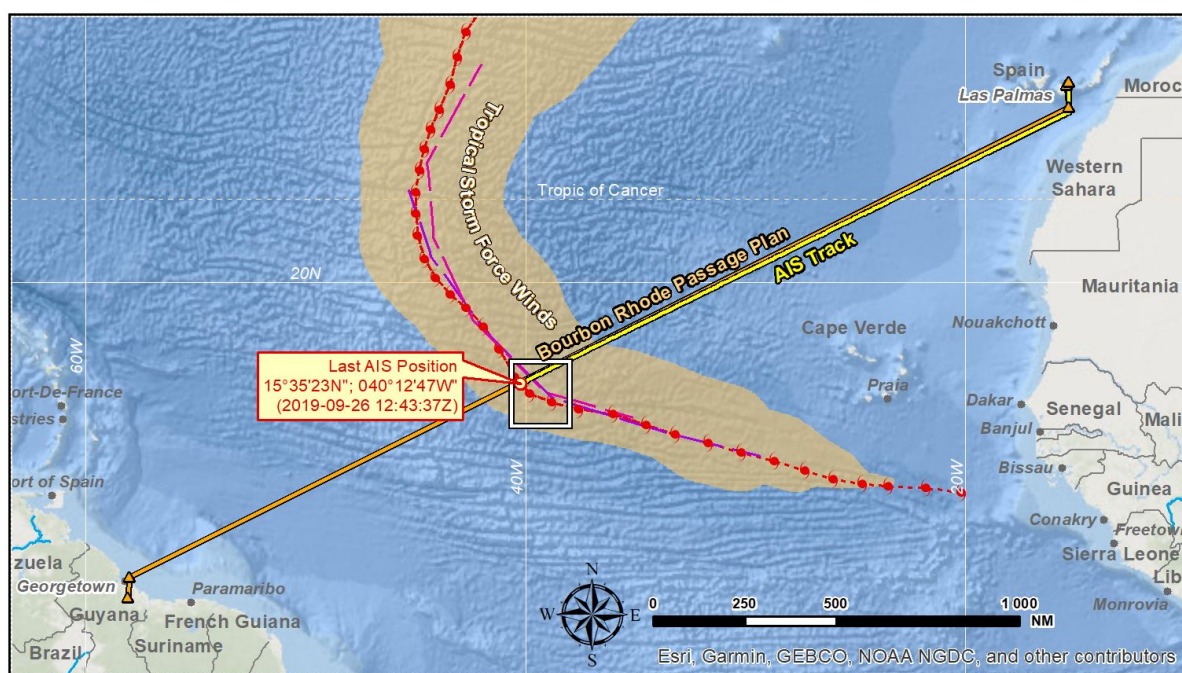
Figure 3.54 – Overview of the actual track of Lorenzo in relation to the vessel's passage plan and AIS track (Source: Esri)

The Figure 3.54 provides an overview of the track of Lorenzo with the associated area of tropical storm force winds in relation to the vessel's track and shows the extent of the frame used for the analysis of the predicted track errors of Lorenzo for the selected date and time.

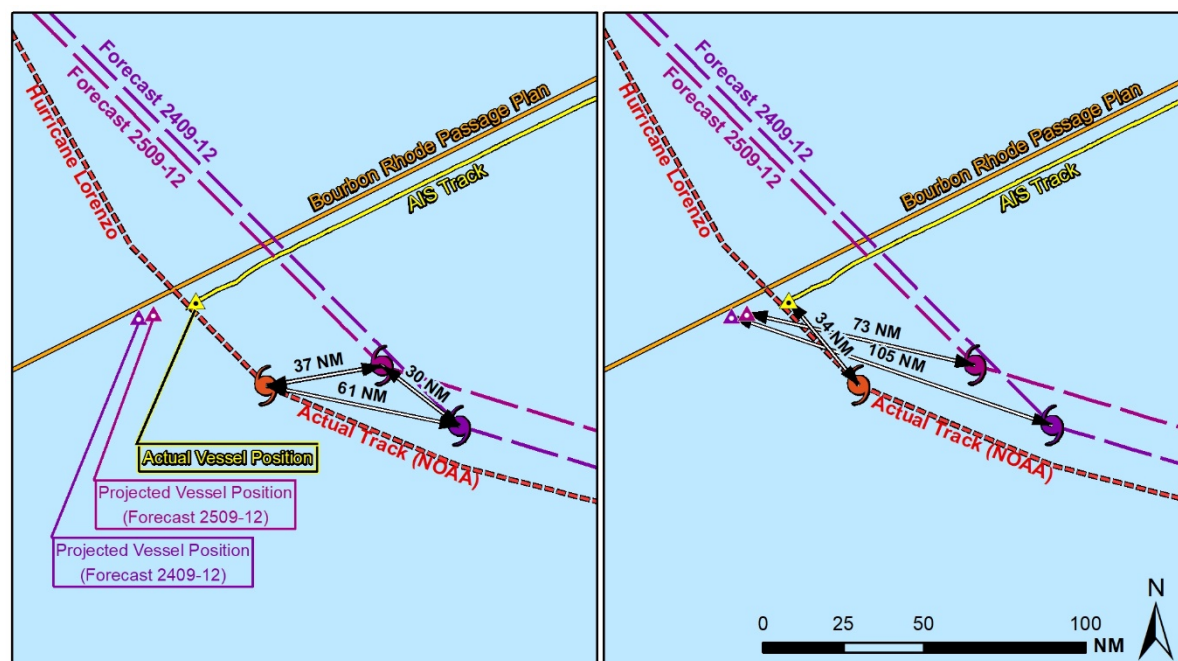
Figure 3.55 – Graphical representation of Hurricane Lorenzo's predicted track errors

The Figure 3.55 shows the predicted position of hurricane Lorenzo from the HSFAT2 forecast from 24 and 25 September 2019, valid for 26 September 2019 at 12:00, and the actual hurricane position in relation to the vessel's AIS track.

- the distance between the predicted hurricane position from the forecasts dated 24 and 25 September 2019 and the vessel's projected position on 26 September 2019 at 12:00;
- the actual distance between hurricane Lorenzo's position and the vessel's AIS position on 26 September 2019 at 12:00.

The fact that the hurricane's speed increased and that its actual track first shifted to the southwest before turning to the northwest, combined with the vessel's reduced speed due to the loss of propulsion, put the vessel in closer proximity to the hurricane centre than anticipated. The last received AIS position was located almost on the actual track of Lorenzo and near the eyewall of the hurricane, exposing the crewmembers to life-threatening sea conditions while abandoning ship at around 12:30.

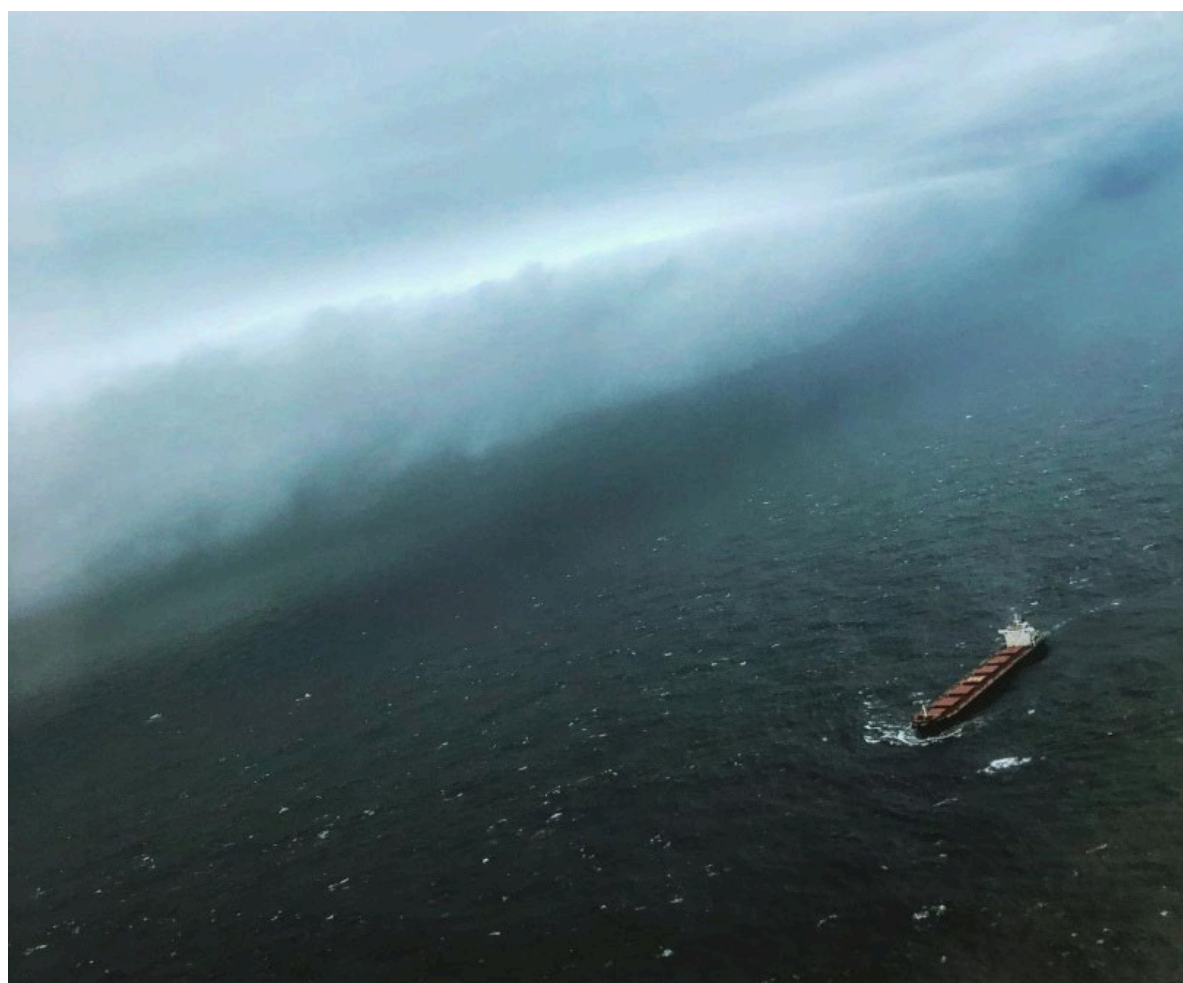
Figure 3.57 – Convective cell in an outer rainband of Hurricane Lorenzo, taken during a NOAA43 SAR mission on 27 September 2019. The *SSI Excellent* is also pictured.
(Source: Kelly Ryan, NOAA/AOML/HRD)

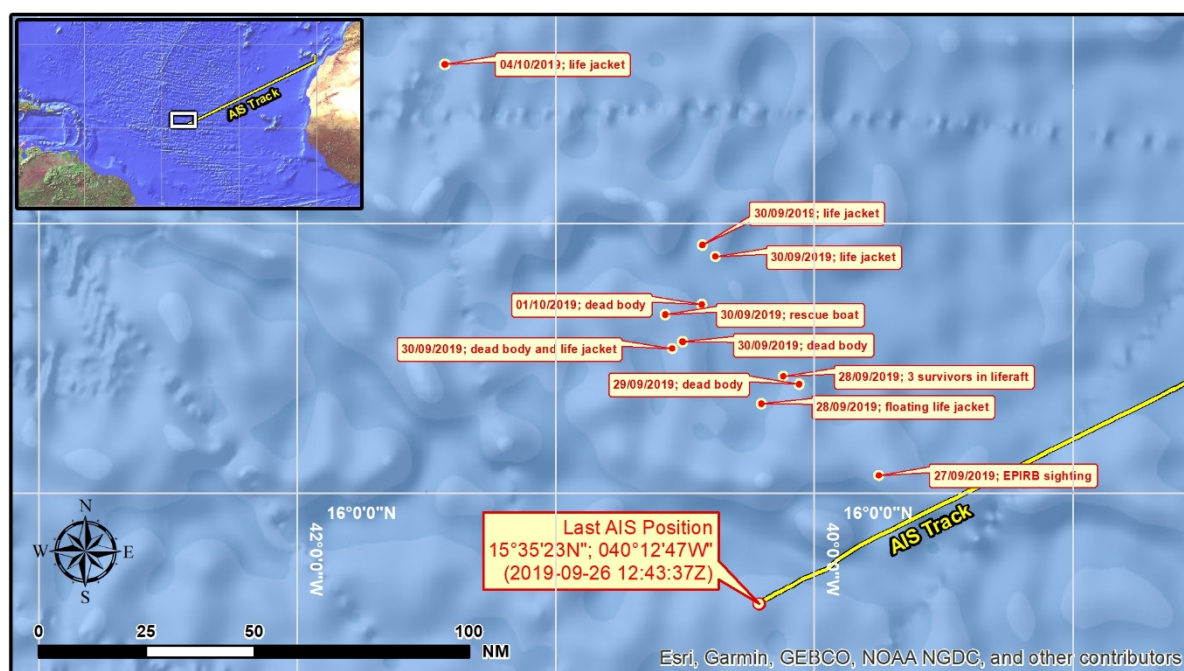
Figure 3.58 – Graphical representation of the sighting and recovery positions
(Source: Esri)

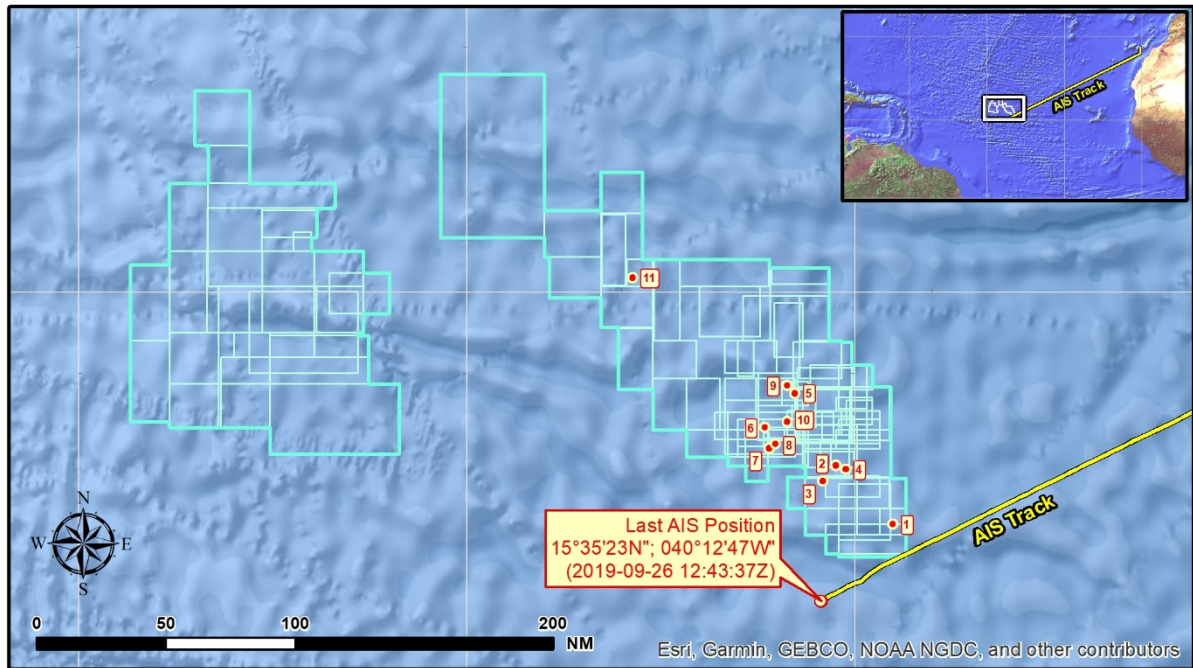
The SAR operations can be considered as a multinational effort at high seas, involving 20 vessels and 15 aircraft overflights. As shown in Figure 3.59, the extent of the SAR zones allocated by the MRCC Fort-de-France covered more than 73.000 km², the area searched by active means³² exceeded 109.000 km².

Figure 3.59 – Graphical representation of the SAR areas allocated by the MRCC Fort-de-France
(Source: Esri)

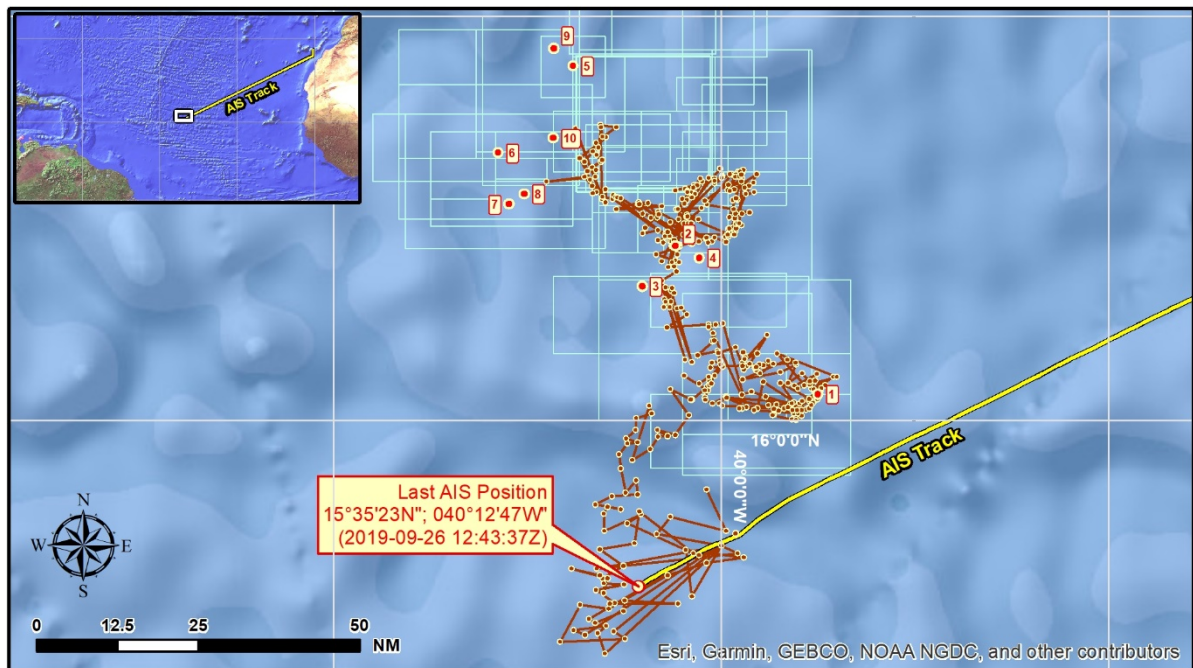
Figure 3.60 – Graphical representation of the EPIRB positions
(Source: Esri)
