SERIOUS INCIDENT INVOLVING THE BOMBARDIER DHC-8-402, REGISTERED LX-LGG, OPERATED BY LUXAIR AND A REMOTELY PILOTED AIRCRAFT SYSTEM (RPAS) IN LUXEMBOURG ON 14 APRIL 2015

Report N° AET/AC-2018/01

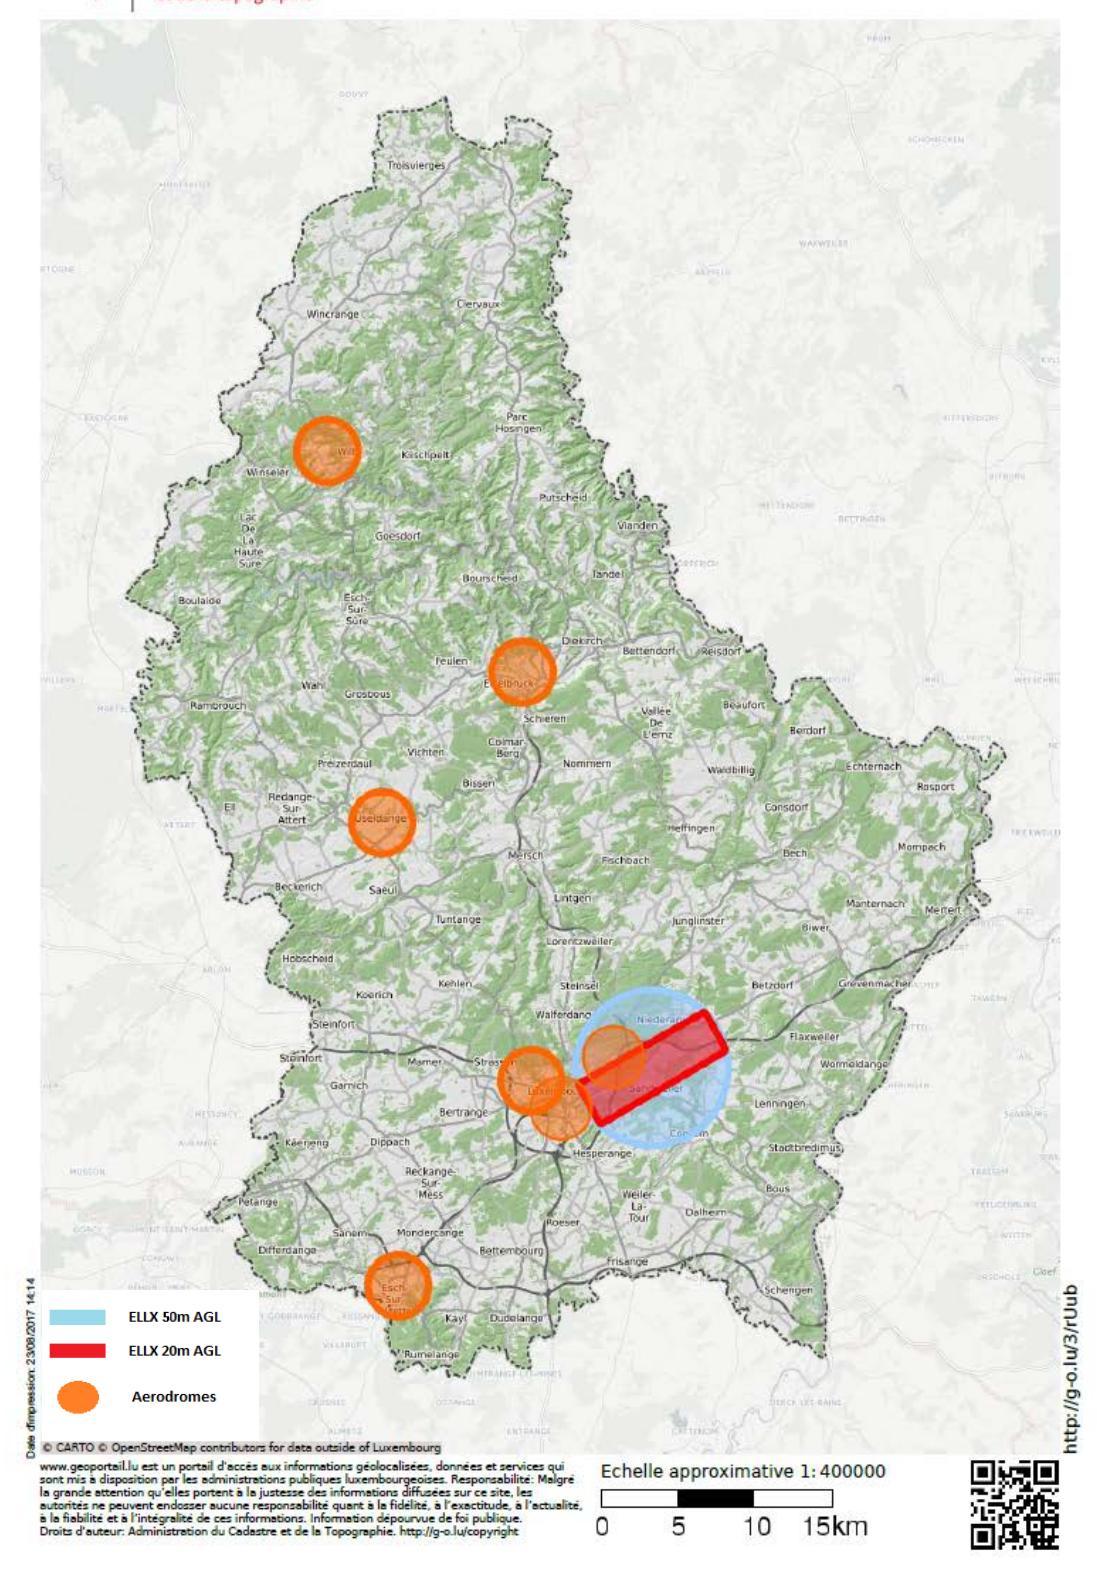
RPAS - Luxembourg Airspace Restrictions

An authorization form for UAS and a link to the map on the government geoportal displaying the RPAS Luxembourg Airspace Restrictions chart (see 4 APPENDIX - RPAS) were published on the DAC website on 3 November 2016.
